CASE STUDY

EMERGENCY VESSEL INSPECTION LEADS TO ALL HANDS ON DECK FOR LARGE-SCALE EMERGENCY REPAIR

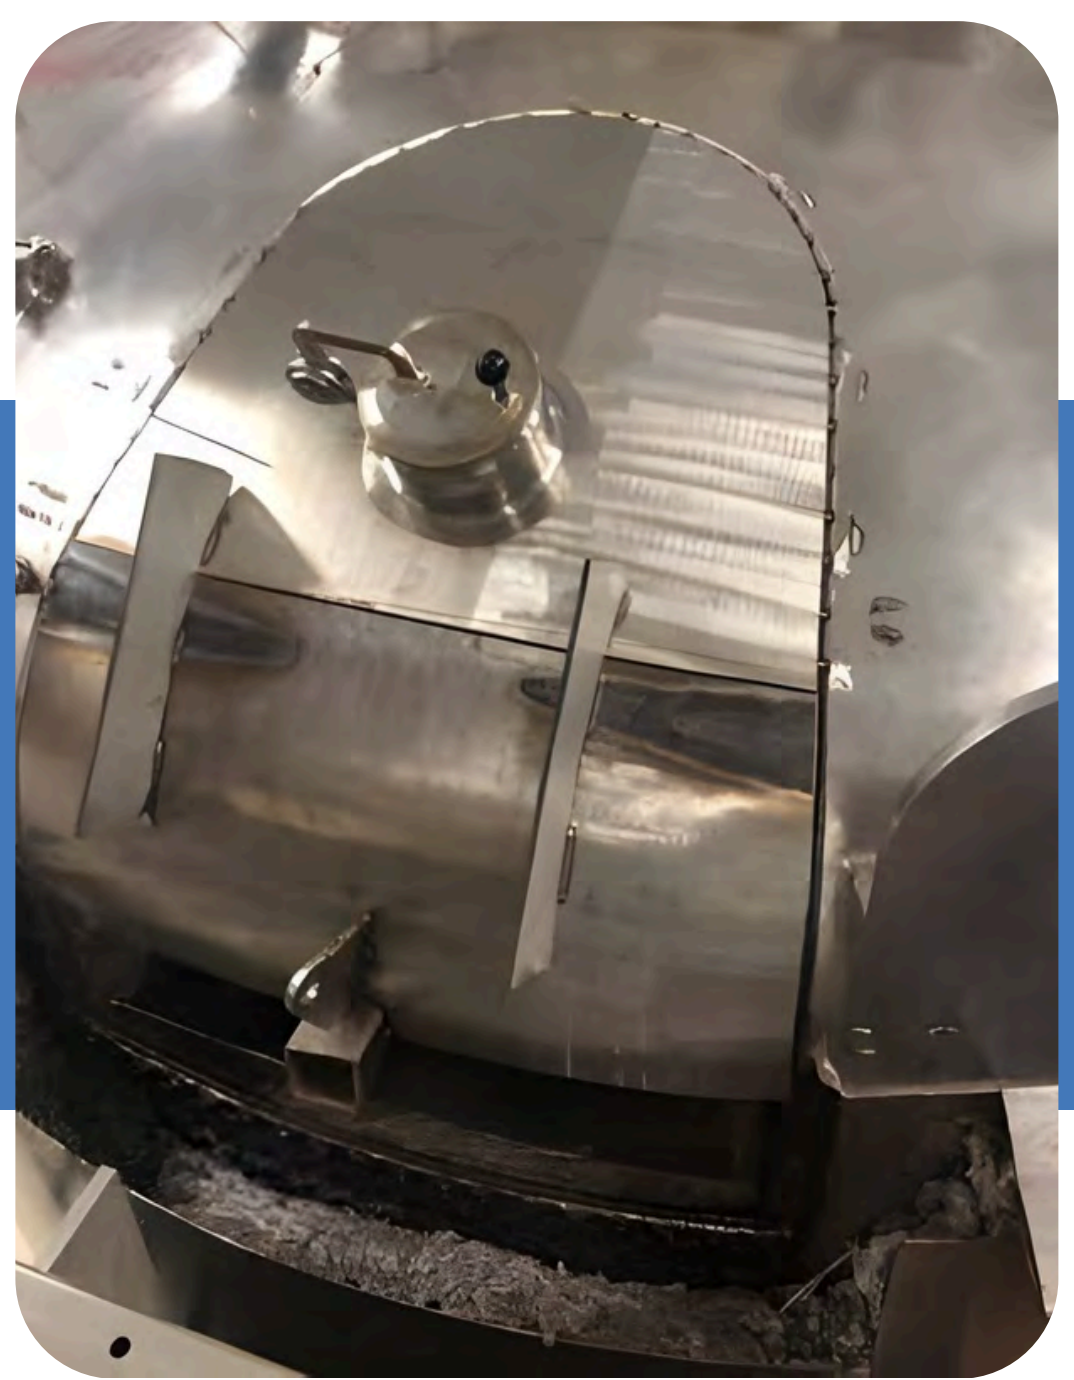
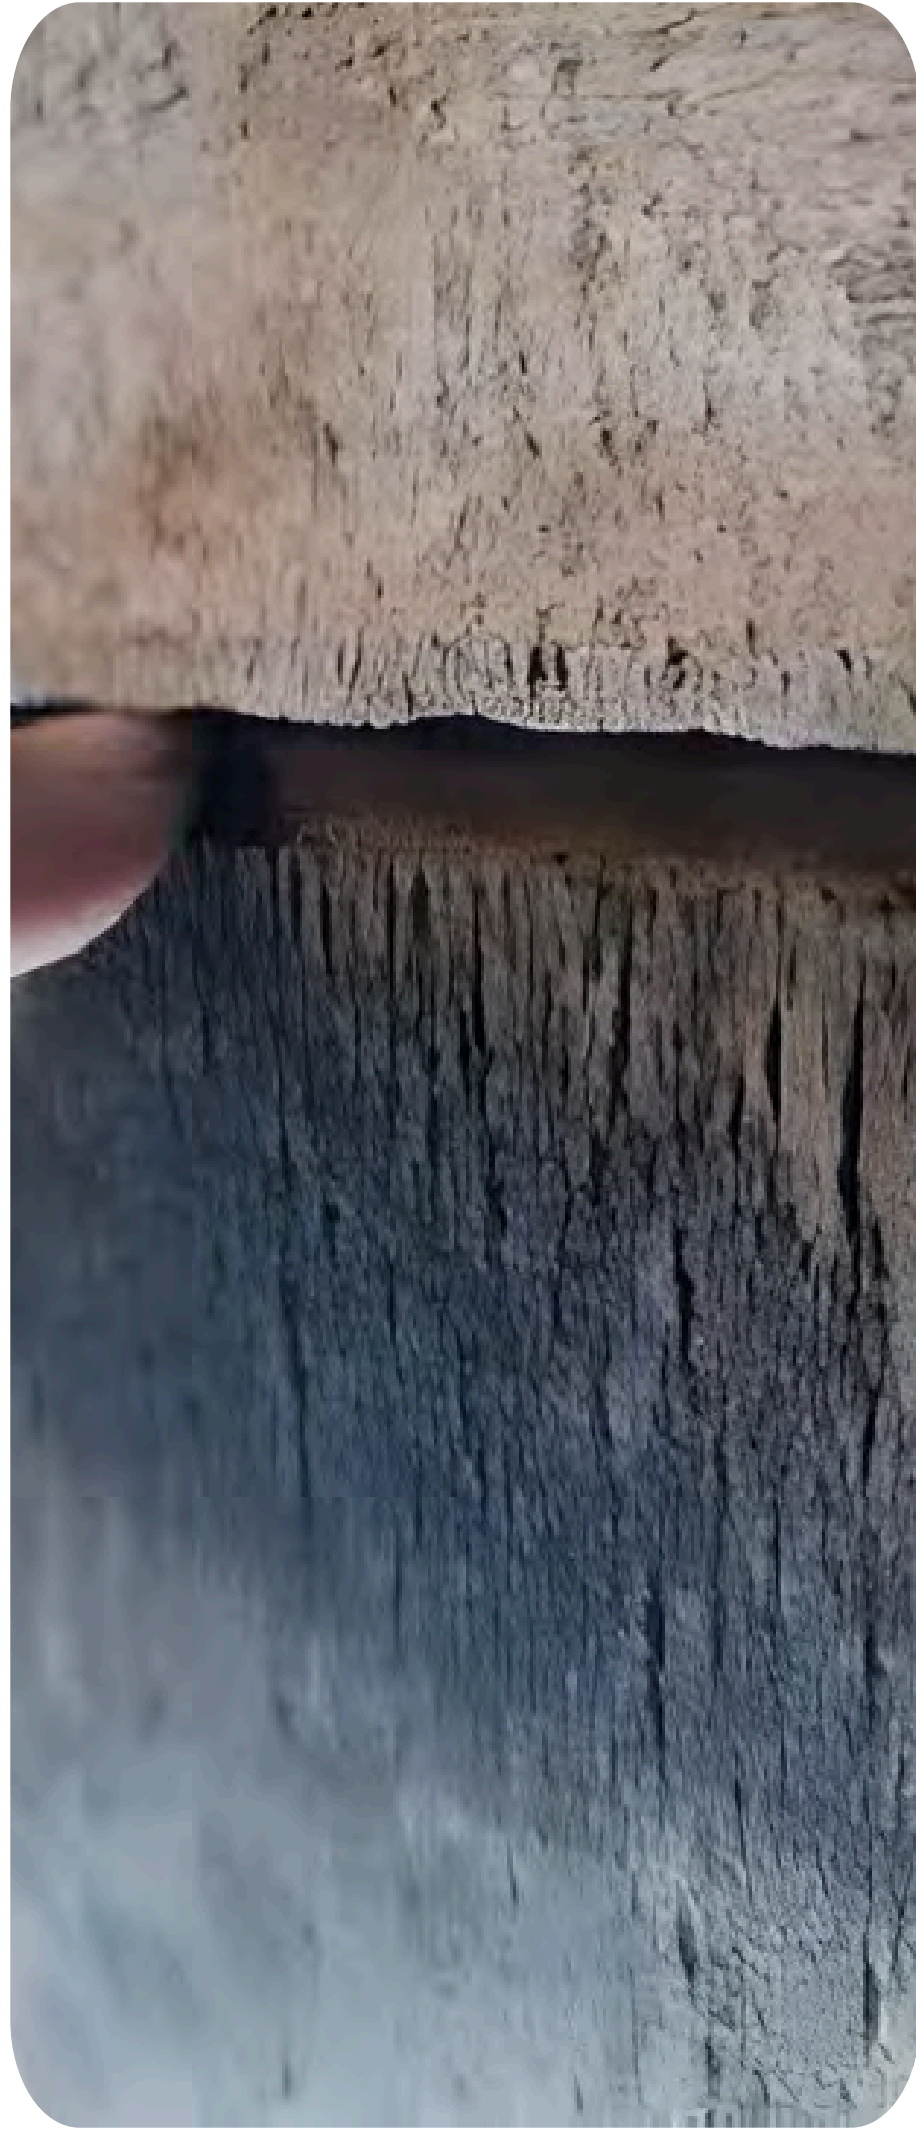
ABEC technicians inspected the 25,000L vessel and found extreme pitting and corrosion near the 6" ferrule in the top head, and down through the sidewall to the liquid level. The 5,000L vessel was in slightly better shape than the 25,000L, but also had very bad pitting and corrosion around the 6" ferrule, mixing baffles, and the shell.

- Removed the corroded 30" x 30" top head section of the 25,000L vessel and sent it to ABEC's Springfield facility as a template for a new duplicate piece. Installed new 6" ferrule in-house to save field time.
- Cut out the corroded sidewall section and peeled back the external dimpled heat transfer material.
- Welded in the new sidewall piece and restored the external heat transfer.
- Fit and welded the new top head with ferrule pre-installed.
- Third-party inspection team X-rayed all welds.
- After verification, third-party inspector approved the repair and witnessed a hydro test of the vessel and heat transfer jacket.

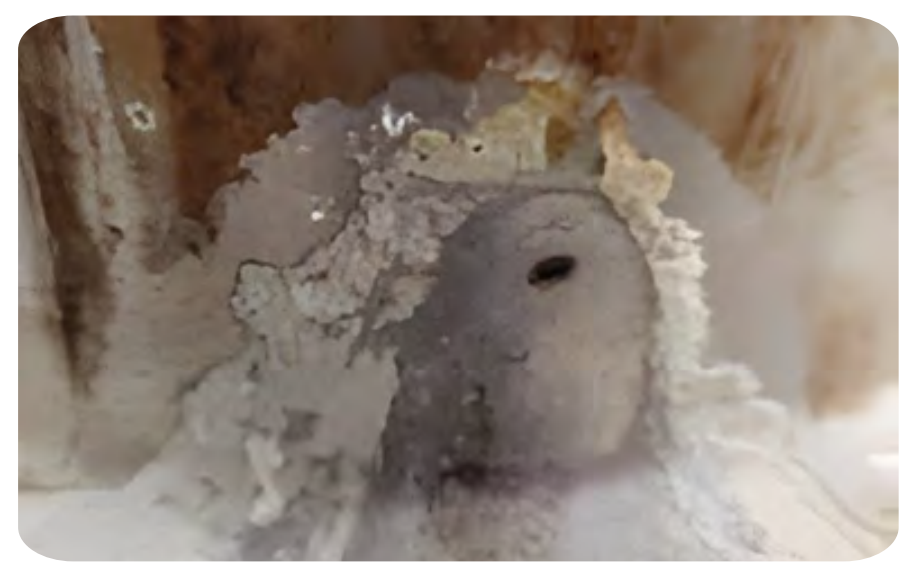
Image Details: 25,000L vessel corrosion and pitting on the top and shell seam

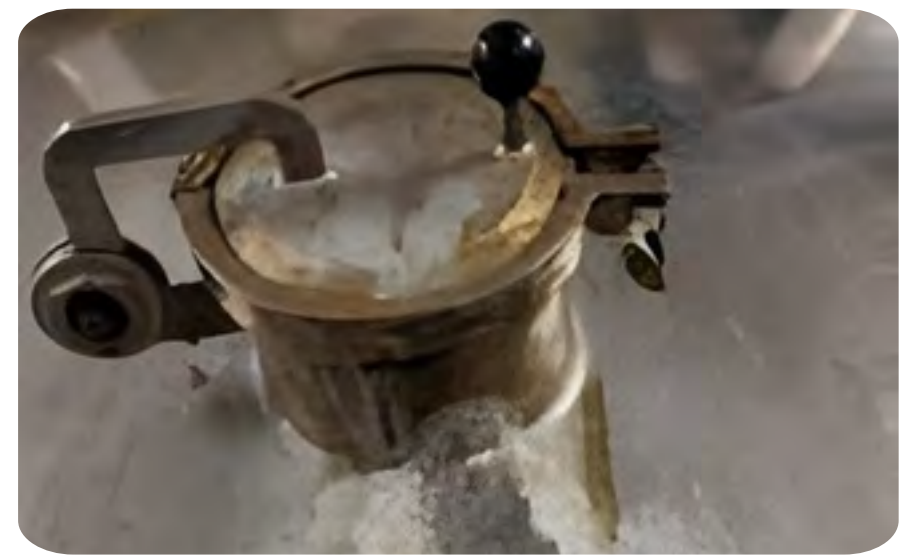
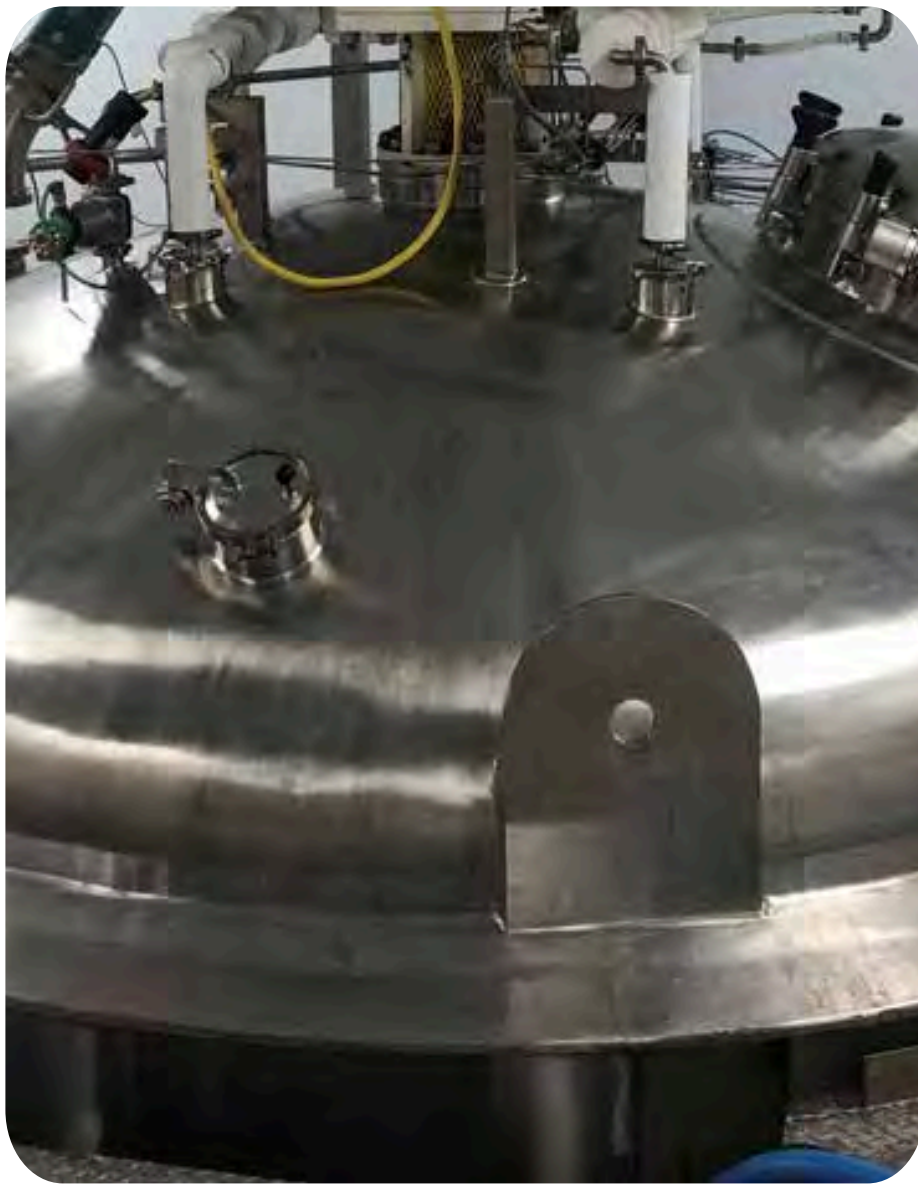
Image Details: ASME repaired 25,000L vessel
