CASE STUDY

FIELD REPLACEMENT OF 4,000L VESSEL DISH END

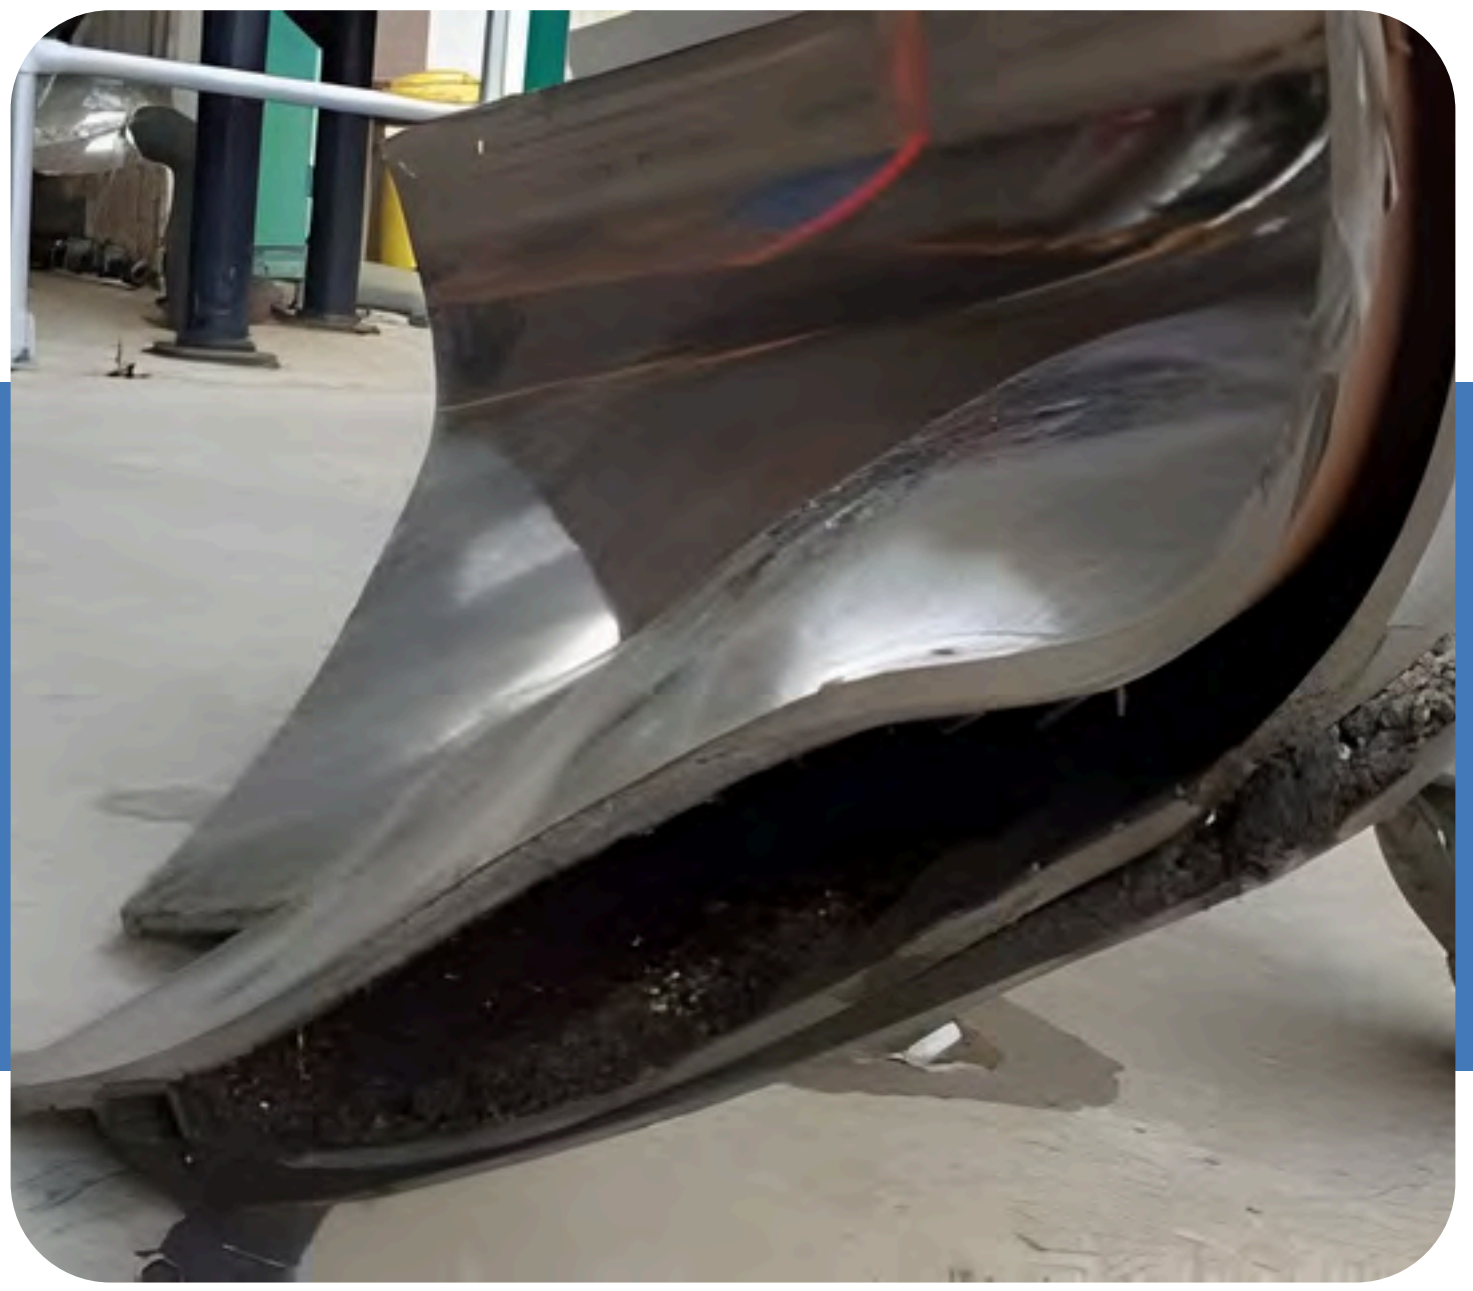
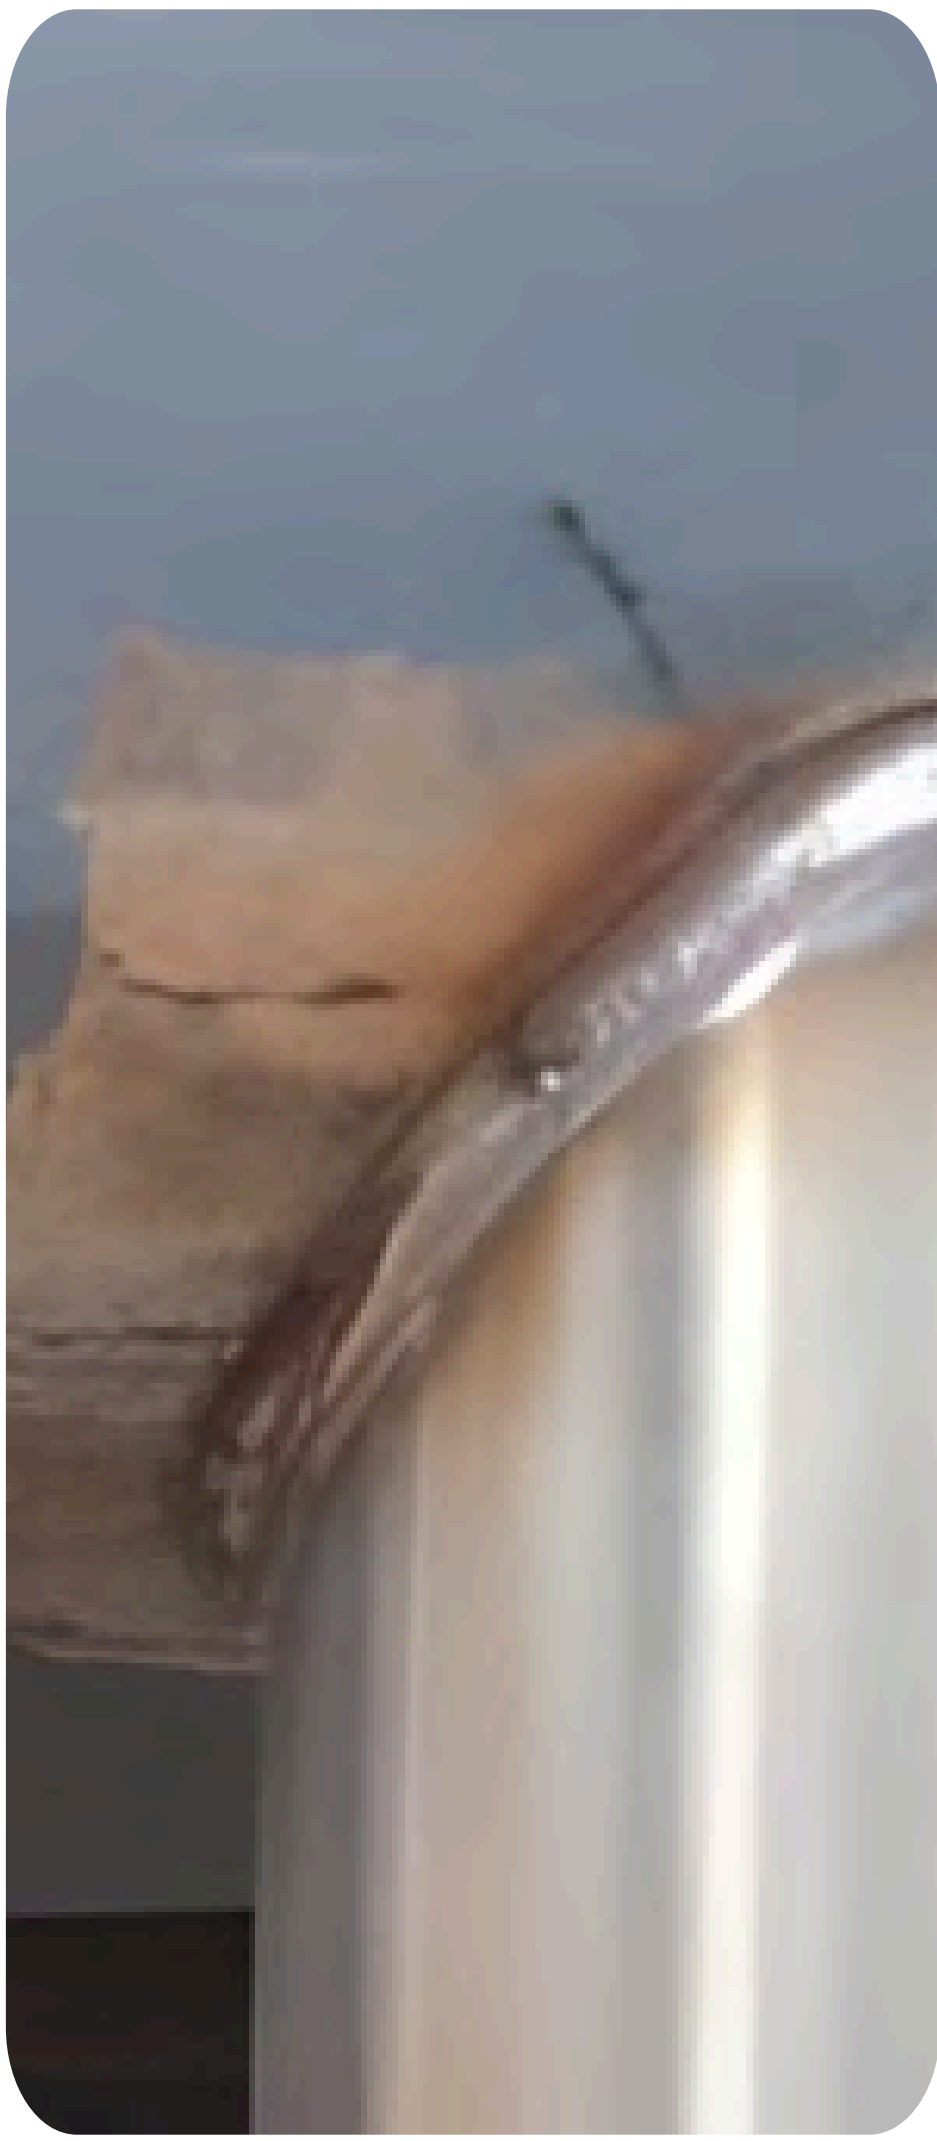
A manufacturer of crucial vaccines within a highly sanitary facility contacted ABEC when they were experiencing issues with their non ABEC 20+ year old vessels. Despite the rigorous sanitation measures, the customer encountered a significant setback when their vessel was suffering from scratches and rouging, resulting in frequent breakdowns and reduced efficiency during production. This caused an increased risk for contamination. The ABEC team of skilled and experienced technicians immediately began to assess the problems and provide the customer with a customized solution.

- Off-site Workshop fabrication of new dish end in advance of on-site schedule
- Replacement of a 4,000L vessel dish end
- VIP on seven vessels and cladding repair on fourteen vessels (ABEC VIP Program)

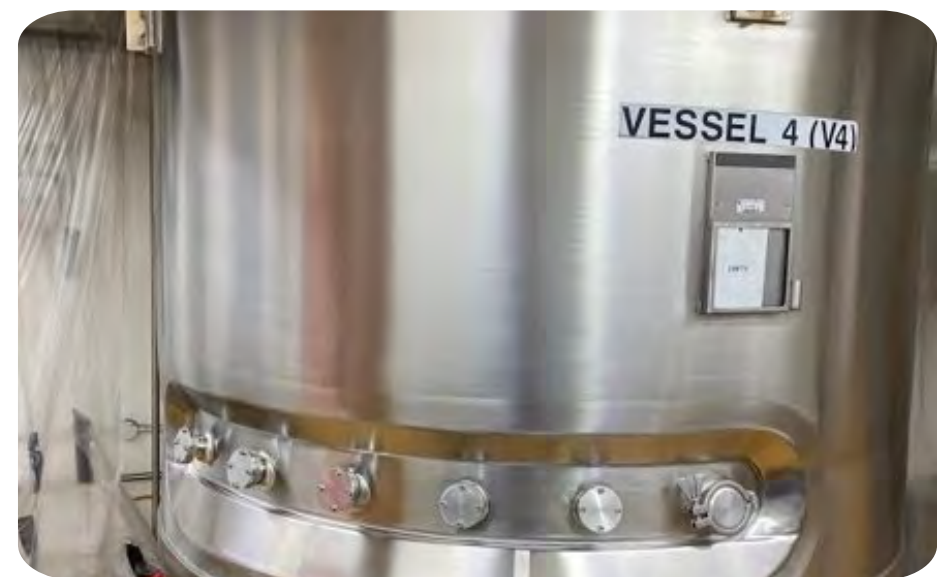
Image Details: Behlow, New bottom head. Ready for install.

ABEC completed the job a day ahead of the estimated timeline. All vessels at the site underwent a full VIP that outlined the overall health and condition of each vessel. The VIP reports created a priority list of remediations that needed to occur on each vessel. Once those vessels were completely remediated ABEC was able to move on to the vessel dish end that needed to be replaced. After completing the dish end replacement ABEC completed the cladding repairs. All site work was completed with zero safety incidents in a very stringent safety environment.
