CASE STUDY

HEAT TRANSFER SURFACE LEAK

Bioreactor Heat Surface Leak.

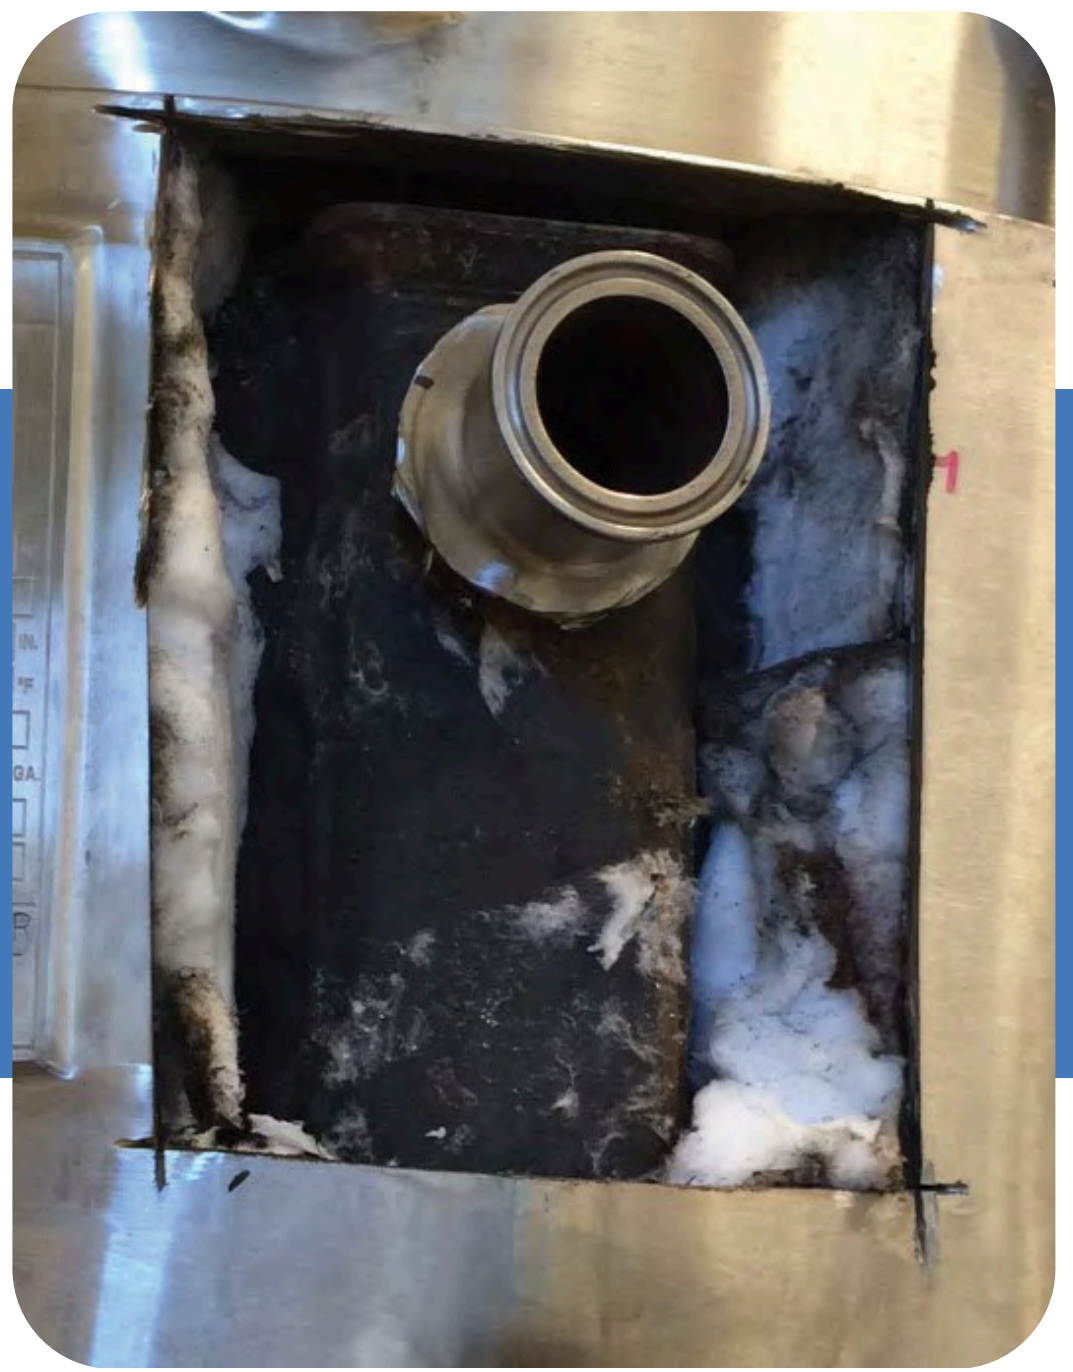
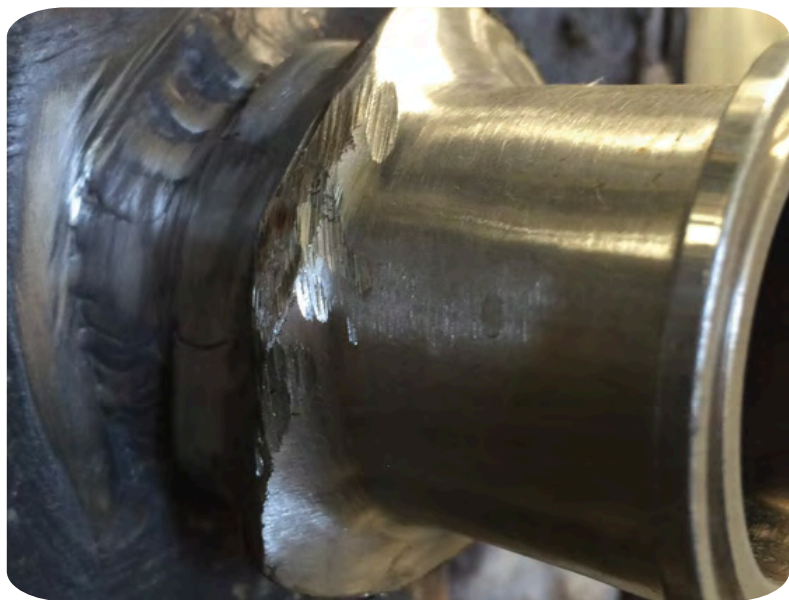
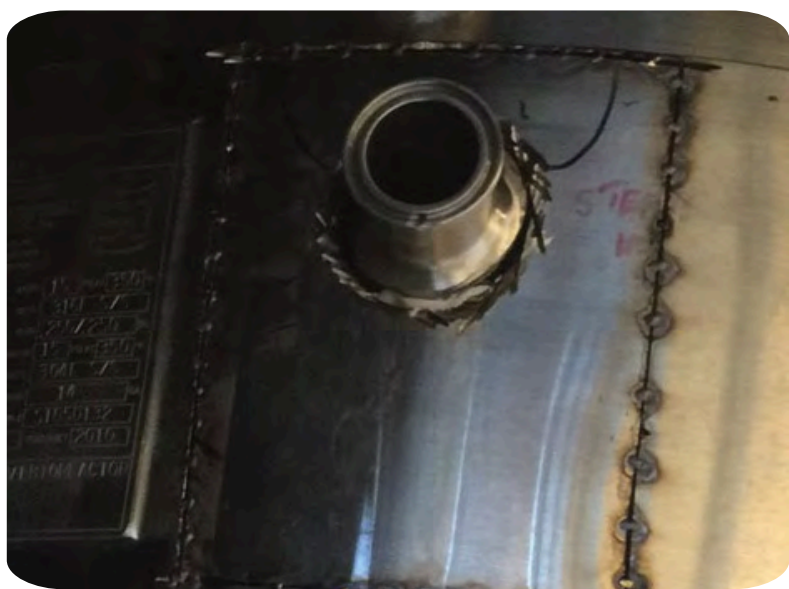
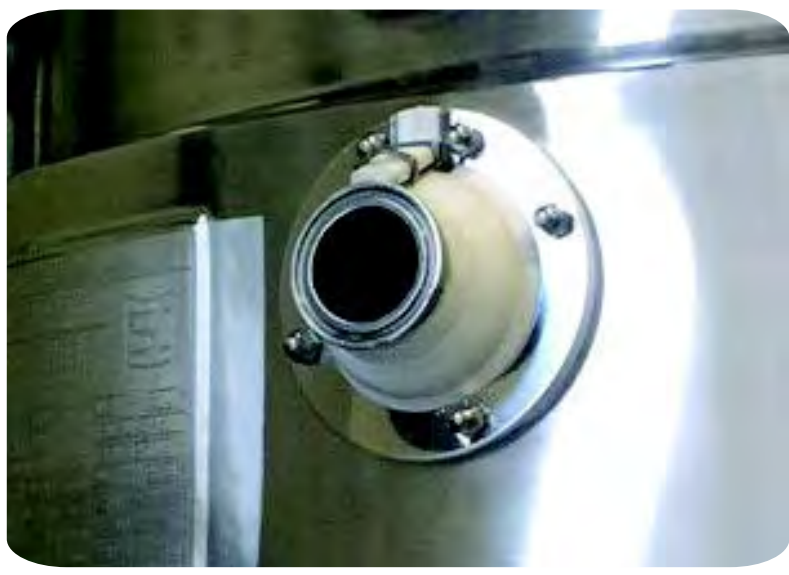
- Located the cracked weld, found on the HTS outlet in the weldment between the HTS pipe and the header
- Inspected the HTS for stress corrosion cracking
- Removed only the sheathing necessary to expose the area of remediation
- Back groove to remove the damaged weld
- Added ASME full penetration weldment
- Hydrotested to satisfy ASME requirements
- Installed flexible boot to absorb movement from thermal shock and to alleviate stress on the connection
- Provided all re-certification and R-stamp documentation

- Identified and repaired a leak caused by thermal shock
- Completed containment of HTS medium
- Reduced stress on the connection from thermal shock
- Vessel exterior, no visual indication of work done
- Vessel back in service within 72 hours
